SUBJECT : SAFETY OF HILL SLOPES AROUND NAINI TAL.

Geological report on the stability of the Hillside at Naini-Tal by Mr. J.B. Auden.

REPORT
ON THE
SAFETY OF CERTAIN AREAS
IN
NAINI TAL
1939

BY
A. L. COULSON, D.Sc., D.I.C., F.G.S., F.N.I.,
Superintending Geologist, Geological Survey of India

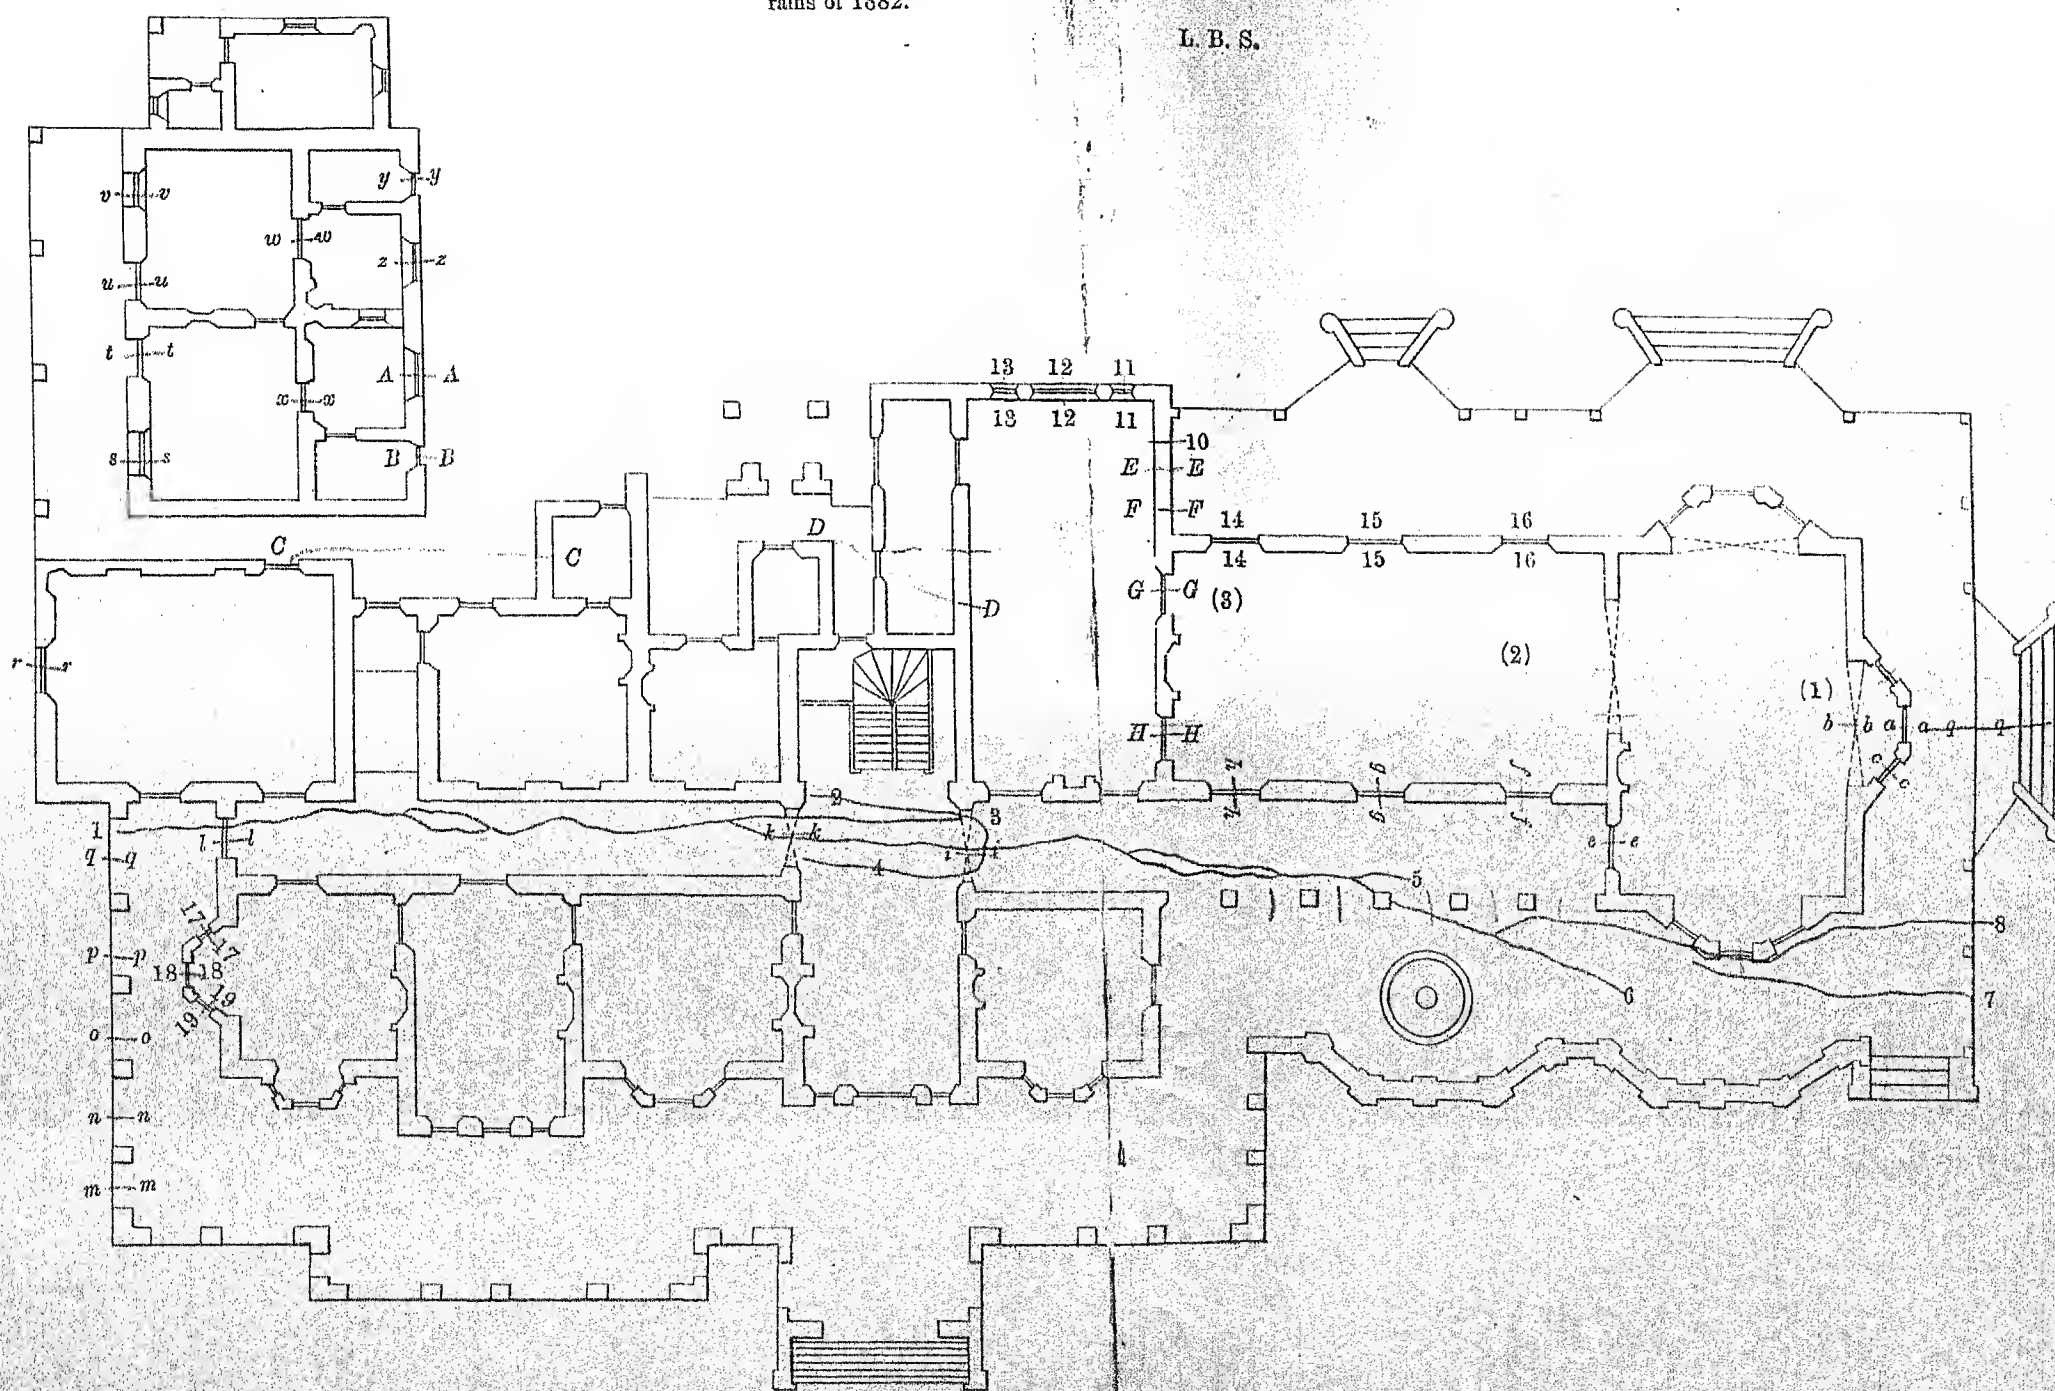
- (9) The floor of the corridor from end to end has cracked considerably and has now been thoroughly repaired.
- (10) In the staff quarters there are considerable cracks in the east wall of the north room over each of the doors, and minor cracks in other parts shown on plan.

- (11) Besides these, there are numerous minor cracks over almost all openings in the lower storey of the building. These are detailed on the plan.
- (12) In the upper storey there is a corresponding crack to that in the lower in the corridor arches, which was filled and papered over in 1881, and which has since shown no sign of increase, as the paper on the arches is unbroken. There is also a separation between the upright woodwork at the end of the corridor and the wall, as shown in margin, but this cannot be depended on as evidence of separation in the building to the extent indicated, as much may be due to shrinkage of the wood.

5. (ii) *Probable causes of the present defective state of the building.*—The Committee is unanimously of opinion that the cracks, which are all longitudinal, were consequent upon the general disturbance of the hill during the cyclone of September 1880.

6. Mr. Ashhurst and Mr. Henslowe also are of opinion that unequal consistency in the subsoil under foundations has probably tended to increase the cracks, which tendency might perhaps have been prevented had a broader and thicker beam of concrete been given under each of the walls than it is understood has been provided.

The blue lines show the cracks that have been re-repaired
in 1883.
The red lines show those that have not been touched since the
rains of 1882.

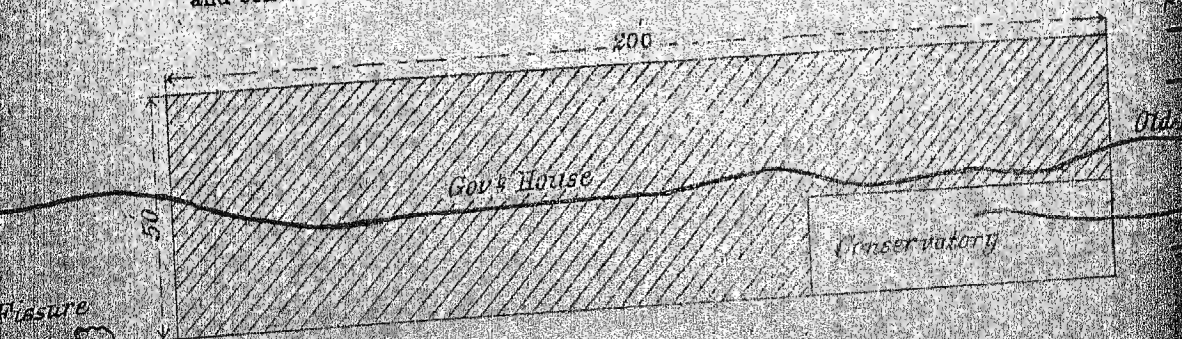
IN re-roofing the conservatory, the pillars that had got out of plumb, and gave rise to suspicions about the failure of the foundations, have been set up straight. Two small slate slabs have been let in, at ground level, on either side of the passage, and a steel bar has been made to fit accurately between them. This bar will be kept on the spot, and any subsidence of the outer wall can be, by this means, easily detected. I do not propose to enter into the question of the cracks but in opening up the drains on the east and west of the house, certain cracks and fissures were noticed, of which I subjoin a sketch. They are not, I believe, any new thing, but are a part of the natural composition of the hill showing movement of expansion and contraction only under atmospheric changes.

The thin red lines show cracks, and the thick irregular lines fissures in the rock, two or three inches wide at the top.

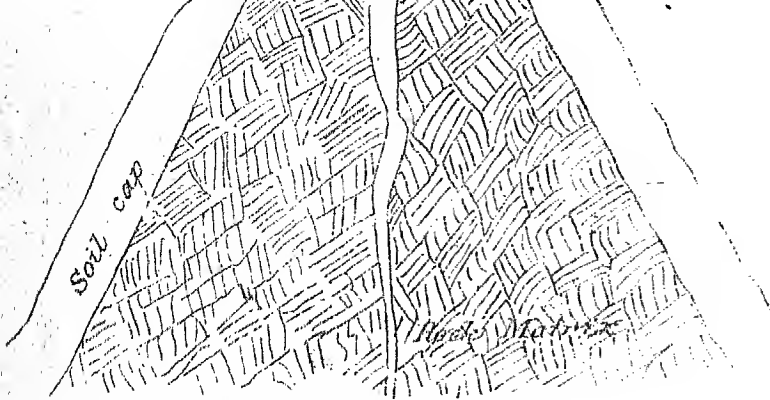
showed him traces of it from Government House to and through "St. Cloud" and on to "Snow View," and he agreed with me that it is no movement of the soil-cap overlying the rocky matrix of the hill, but a distant separation through the axis of the hill itself as roughly indicated in the margin in an exaggerated manner.

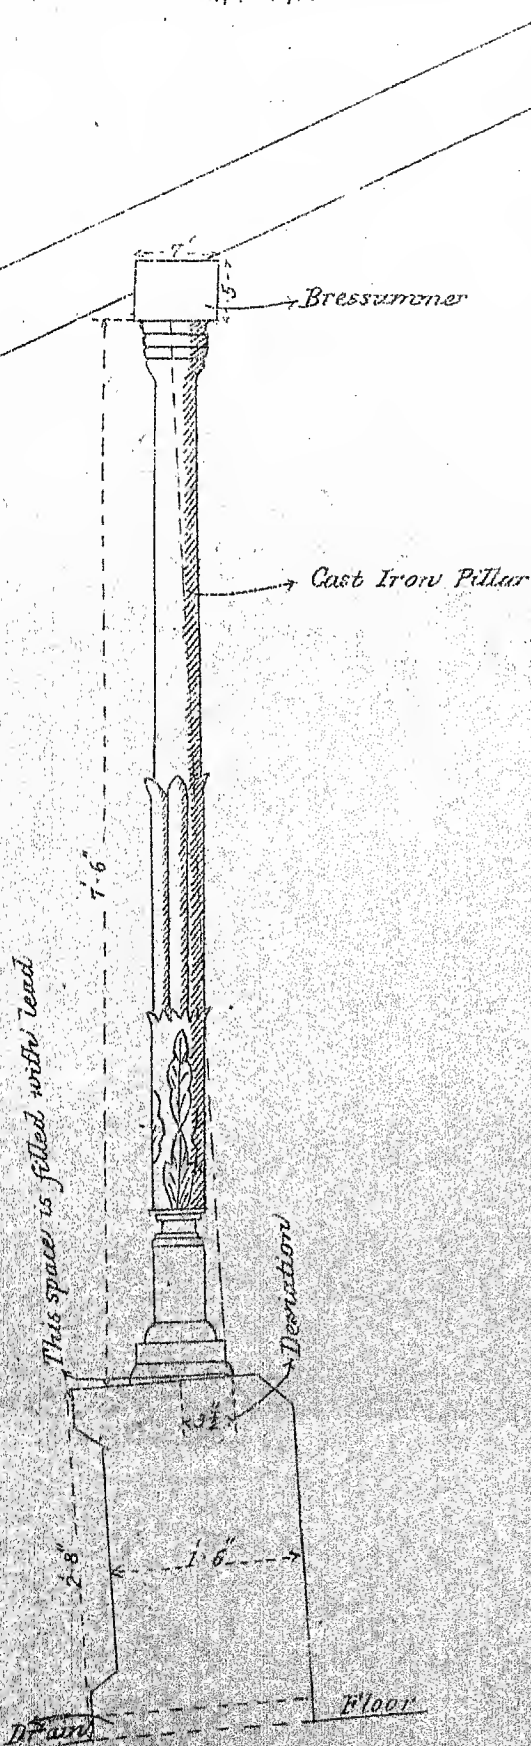
The origin or cause of this separation, and to what extent it has already gone within the hill, it is impossible to ascertain. The surface indications during the last two years show a movement of about one-eighth to a quarter of an inch only. Judging from the separation in the tiled flooring of the corridor and conservatory, and gauged by the deviation of the outer pillars of the conservatory from the vertical, it would appear that since the erection of the house in 1880 the forward movement had not exceeded three inches to $3\frac{1}{2}$ inches as sketched in the margin.

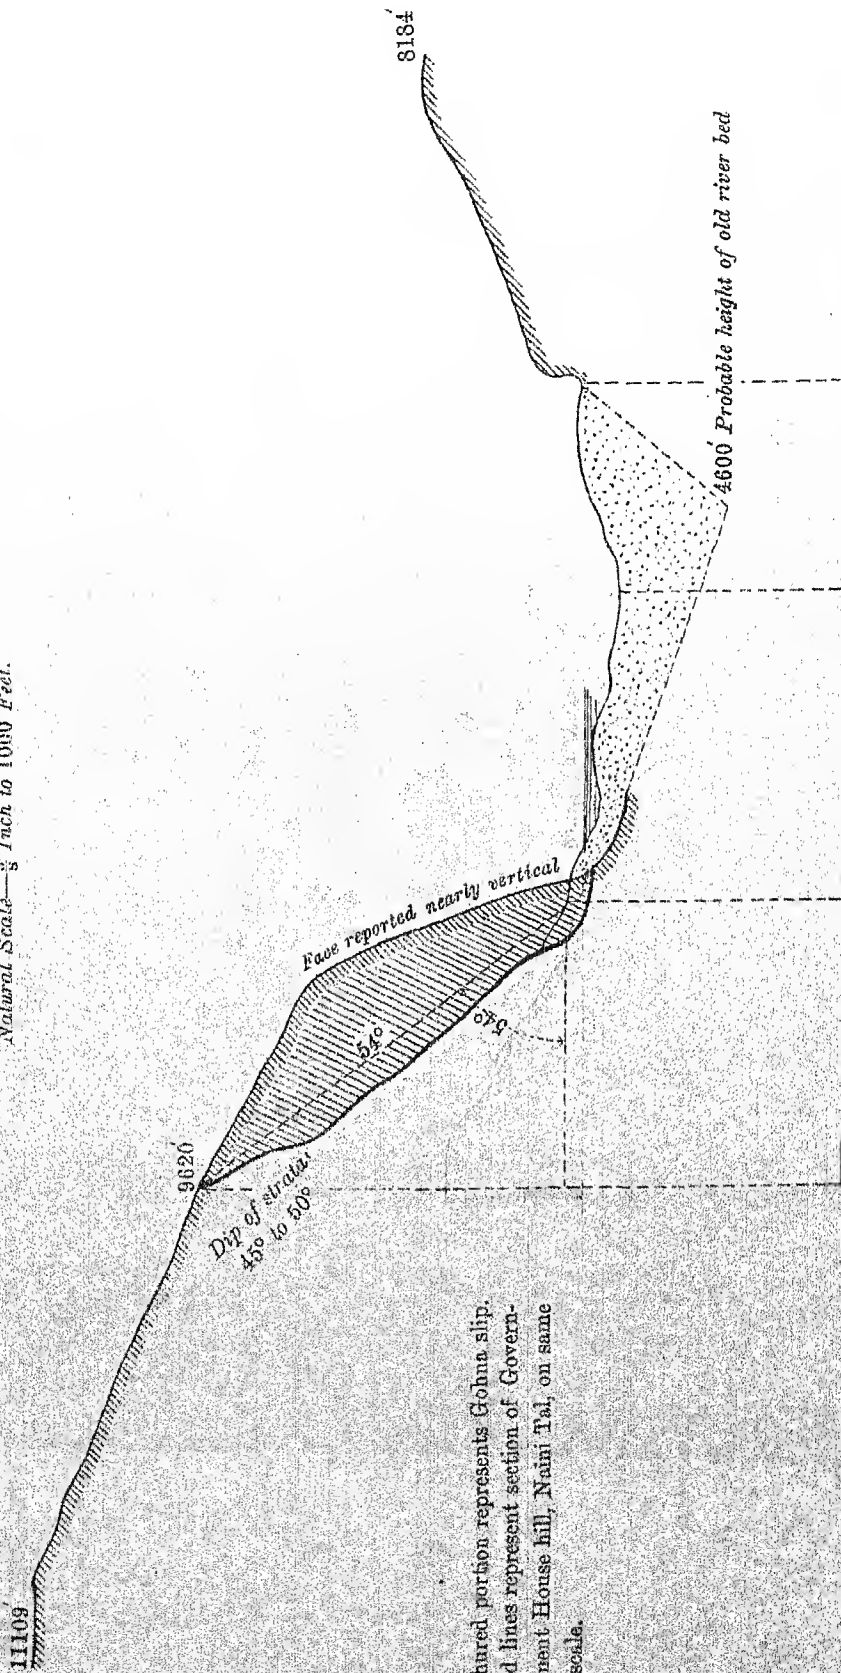
SECTION OF GOVERNMENT HOUSE HILL, NAINI TAL.

Note.—Hatched portion represents Gohna slip.
Red lines represent section of Government House hill, Naini Tal, on same scale.
